Inspect Before You Invest

Inspected By: Greg Cutrone

## Home Inspection Report

Inspected on Mon, May 24 2021 at 9:00 AM

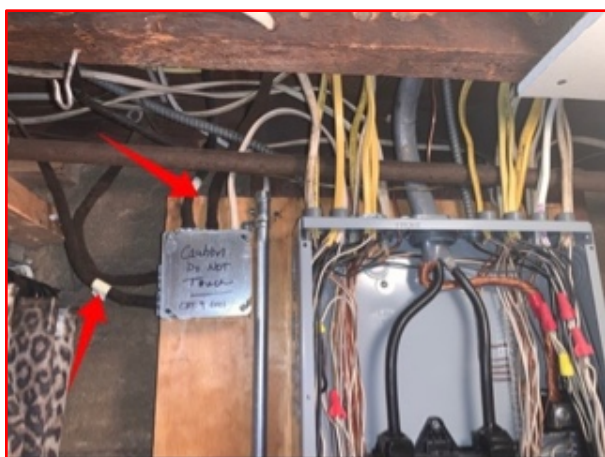
Figure 36-1

1) Comment 36: Knob and Tube appears to have been addressed but recommend having an electrician look at it.

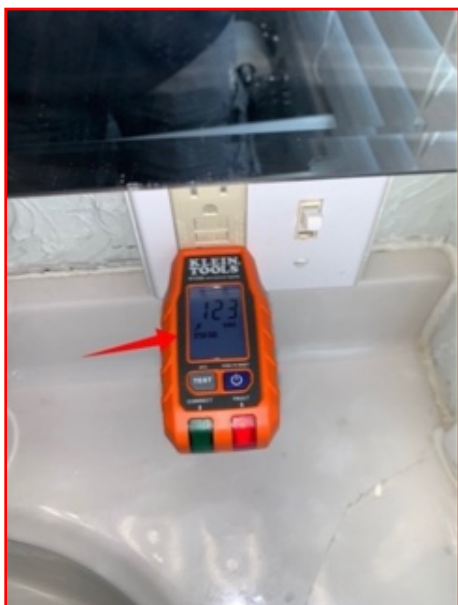
Figure 55-1

3) Comment 55: The outlet in the bathroom is a GFCI outlet but shows an open ground and is not tripping with my test equipment. Recommend hiring a licensed electrician to replace the existing outlet with a working GFCI outlet as necessary or re-wire it if the line coming in is only a 2 wire ungrounded line.

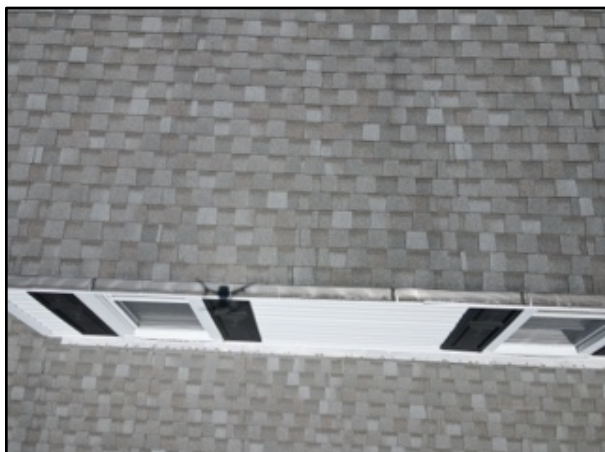
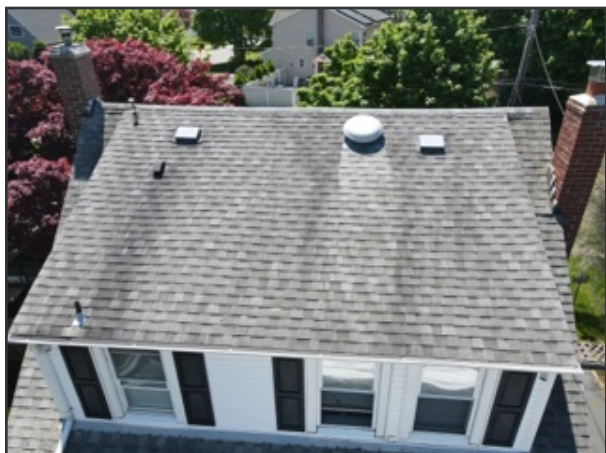
Front Roofing shingles appeared in good working condition. Rear shingles also appeared in good working condition with some discoloration. Covered rear porch roof has broken plastic piece which should be replaced

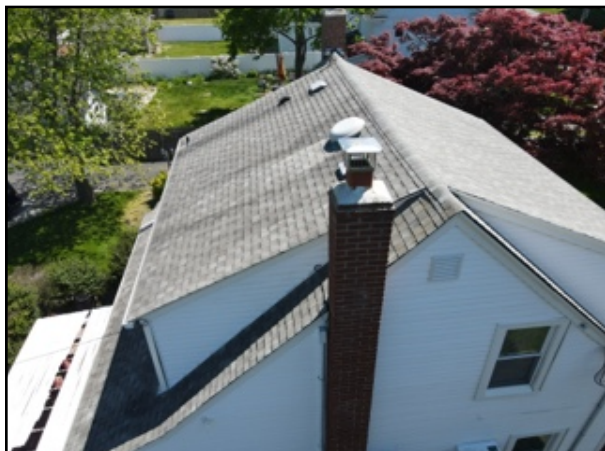
Comment 6:  
West side chimney appeared in good condition.

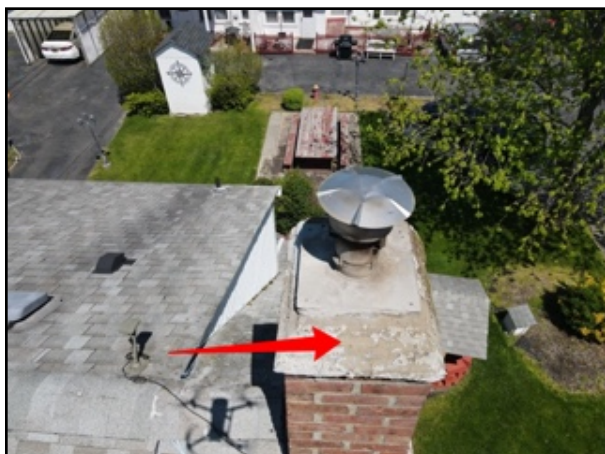
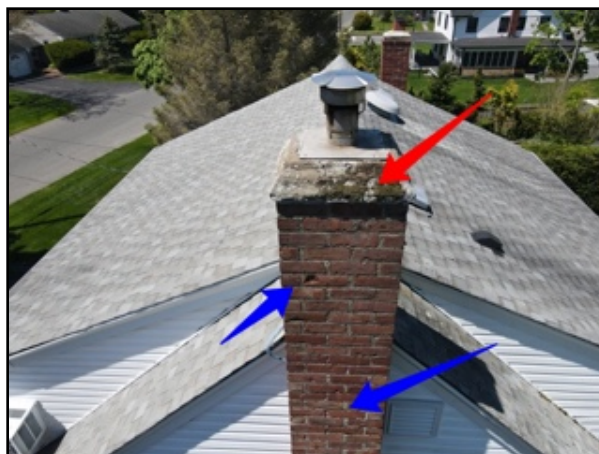
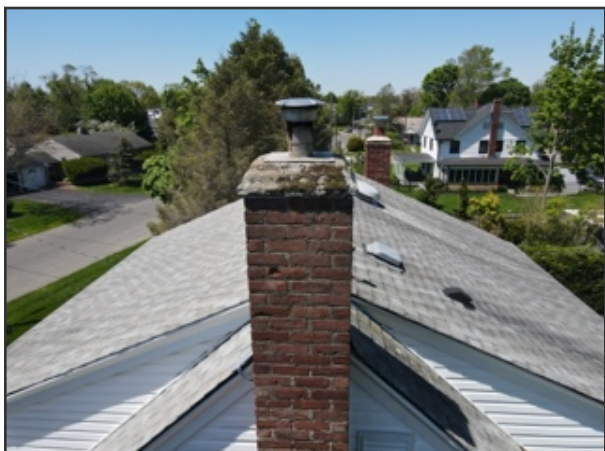
Tar/Caulk  
Condition: Repair or Replace

East side chimney has mold and deterioration on the crown as seen with red arrows in the pictures. Brick and mortar issues as seen with blue arrows. Further evaluation should be done by a chimney professional.

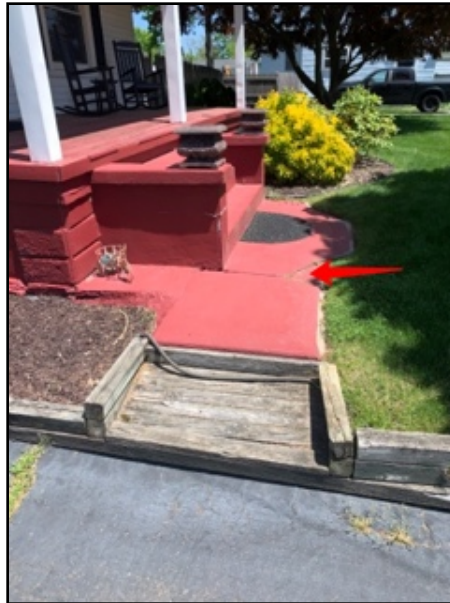
Concrete  
Condition: Marginal

Some cracking, Does not appear to present a tripping hazard yet but could in the future.

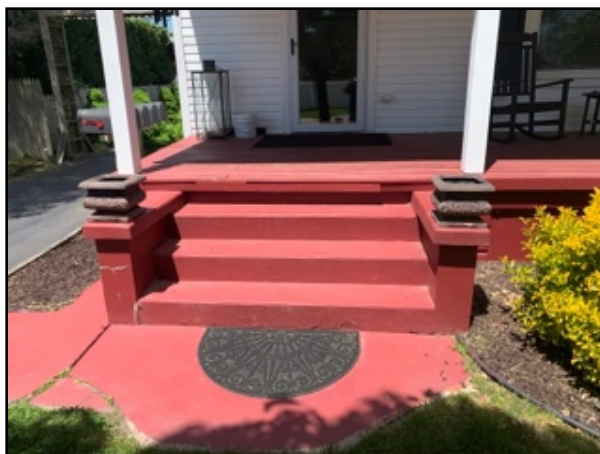
Condition: Further Evaluation Required

No hand or guardrails. For safety they should be installed

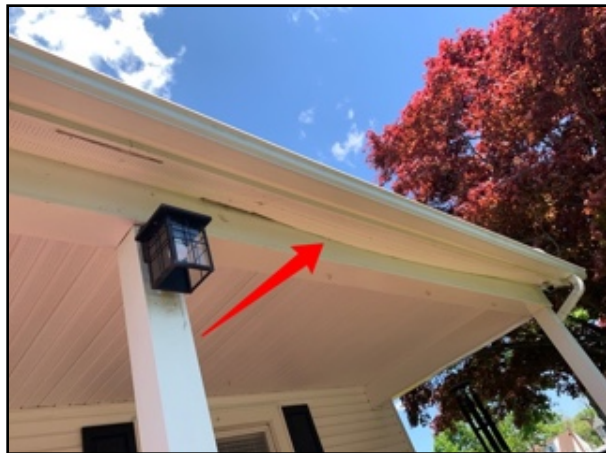
Comment 14:  
One section pulling away.

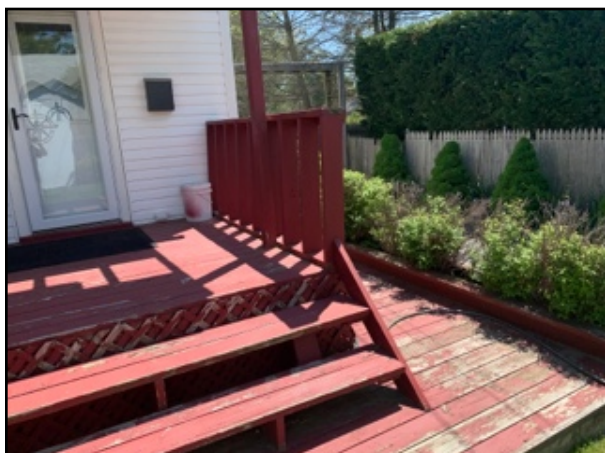
Condition: Repair or Replace

The guardrails are not secure and the handrails are missing.

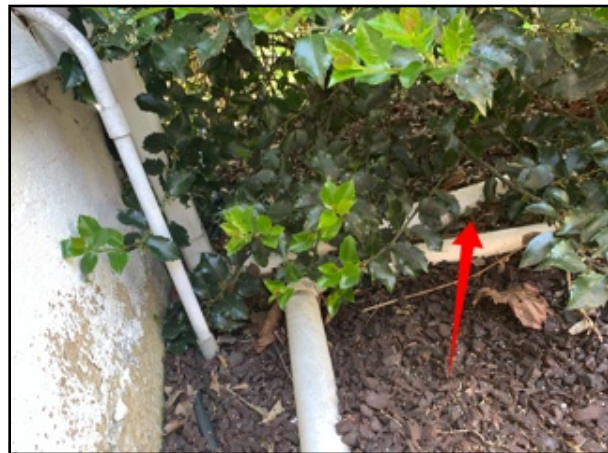
Draining away from the house :).

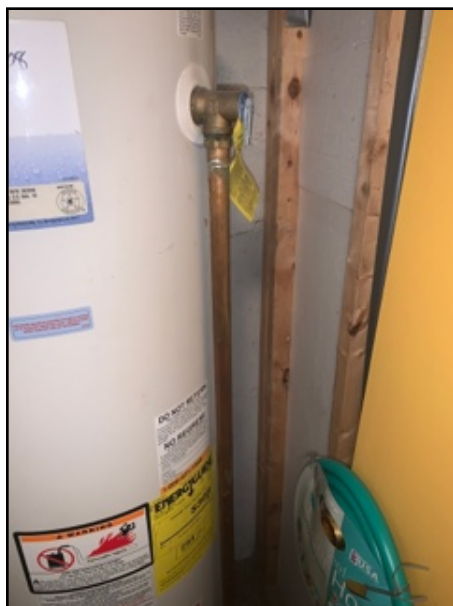
Temp/Pressure Relief Valve: Present with Blow-Off Leg  
Condition: Marginal

Comment 32:  
Should extend to 6" above the floor for safety reasons.

Approx Mfg Date: 2006  
Seismic Straps Installed: No  
Condition: Repair or Replace

Comment 33:  
In the event of an earthquake, straps will prevent the tank from moving, cause damage and possible gas leak.

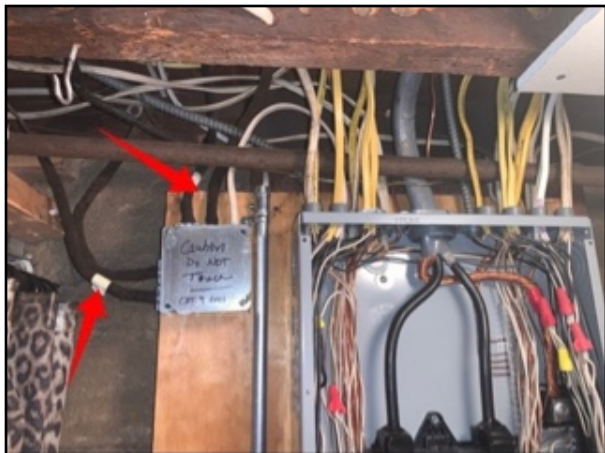
Figure 36-1

Overcurrent Protection: Breakers  
Condition: Satisfactory  
Branch Circuit Wiring: Knob and Tube  
Condition: Further Evaluation Required

Knob and Tube appears to have been addressed but recommend having an electrician look at it.

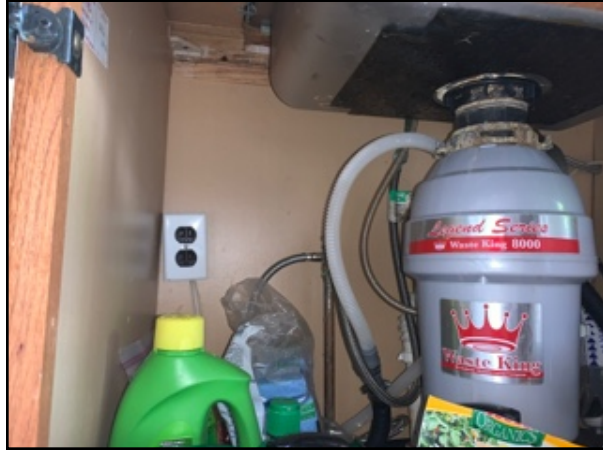
High loop for dishwasher not secure or high enough.  
S trap functional but should be replaced with a P trap

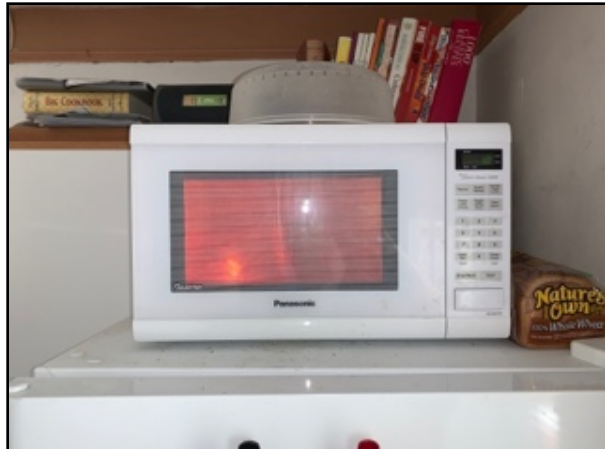
Comment 47:  
Microwave tested showed working.

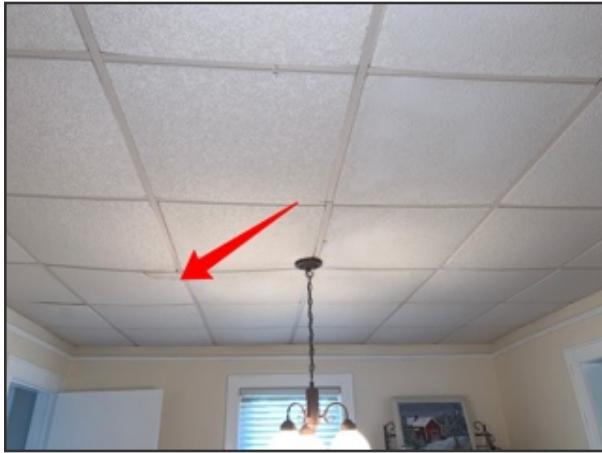
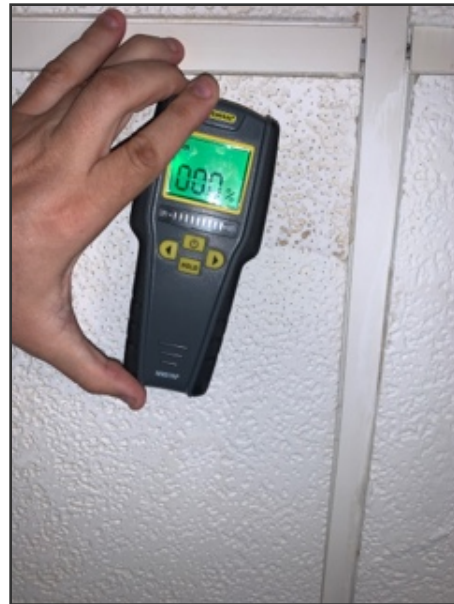
Not sure why a drop ceiling was placed in the dining room but no current signs of moisture were present.

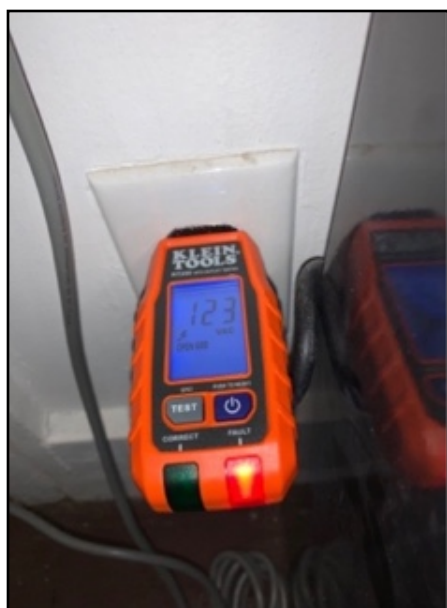
Figure 52-1

Switches and Outlets, Light Fixture, Ceiling Fan  
Condition: Repair or Replace

The outlet in the 3rd Bedroom shows an open ground. Recommend hiring a licensed electrician to re-wire it if the line coming in is only a 2 wire ungrounded line.

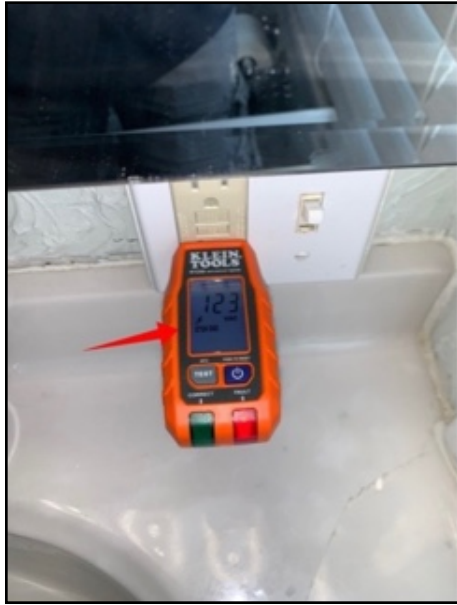
Figure 55-1

The outlet in the bathroom is a GFCI outlet but shows an open ground and is not tripping with my test equipment. Recommend hiring a licensed electrician to replace the existing outlet with a working GFCI outlet as necessary or re-wire it if the line coming in is only a 2 wire ungrounded line.
